INSPECTION REPORT

Galvanized steel pipe / 1500pcs

RELIANCE METAL RESOURCE CO.,LTD
Hi-Tech Building C, #909, Nankai District Tianjin, China

Dec 15th, 2015, Tianjin city, China;

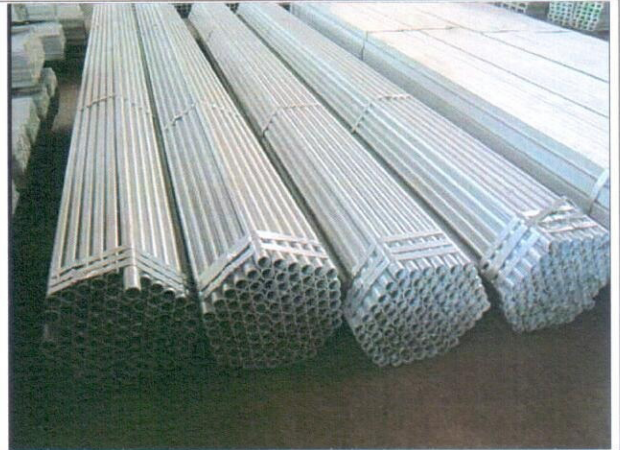
Quantity check

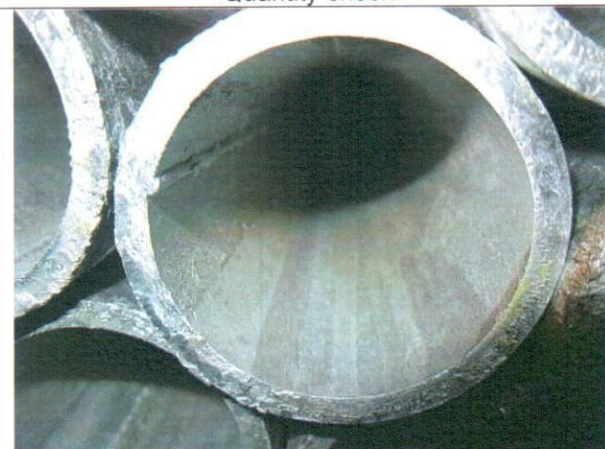
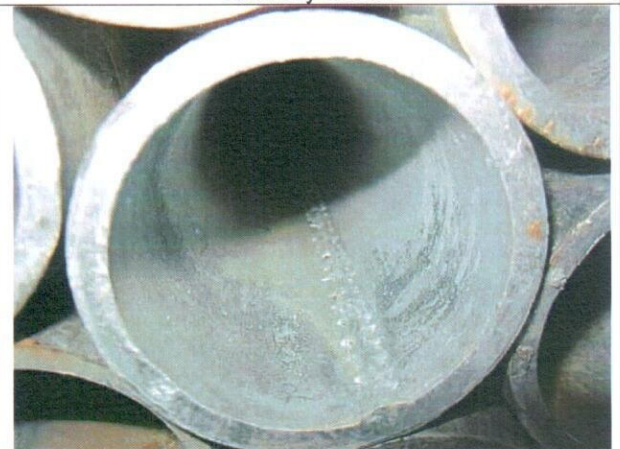
- a) The pipes were silvery color and plain ends.
- b) An internal visible weld seam was found on every inspected pipe.
- c) No other visible defects, such as damage, crack, deformation, etc. were found during the inspection.

Visual quality check

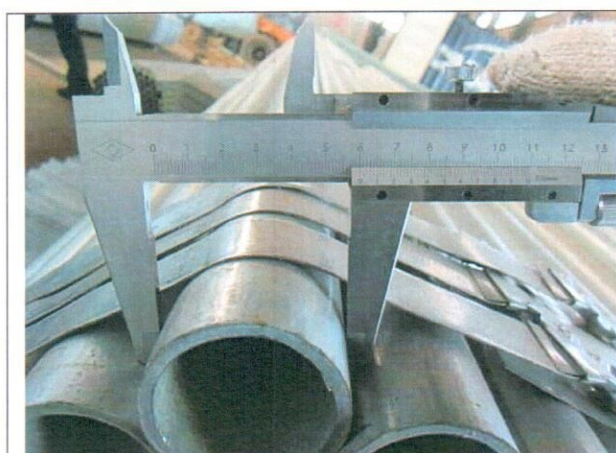
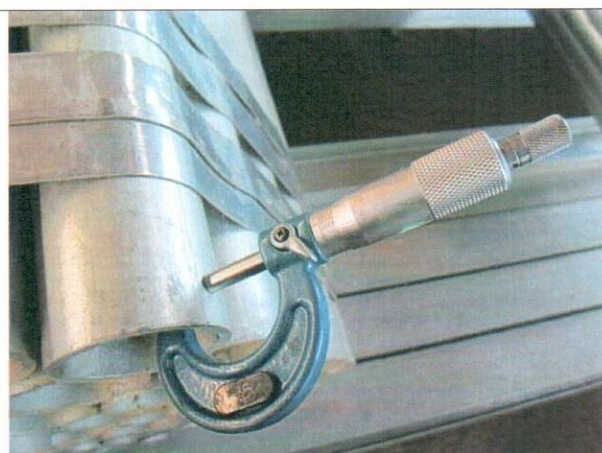
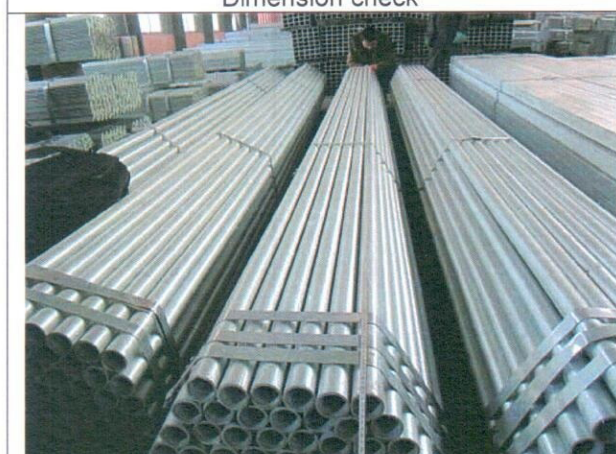
Item	Specification (mm)	Sample size (quantity/samples)	Outer diameter Pipe ends (mm)	Wall thickness (mm)	Length (mm)
Acceptable Tolerance			± 0.3	± 0.2	± 20
1	60x4.5x5800	500pcs / 13pcs	60.0~60.2	4.4~4.5	5805~5810
2	48.3x4.0x5800	1000pcs / 20pcs	48.3~48.4	4.0~4.1	5805~5810

1. The dimension check was performed on the pipes which were necessary and available, according to practical situation on site due to supplier did not open the packing.
2. The length of the pipe was measured from one side end to another end along the pipe body with steel tape.
3. Four measured points were selected randomly for thickness check at pipe ends with micrometer.
4. Two measured points were selected randomly for outer diameter check at pipe ends with vernier caliper.

Dimension check

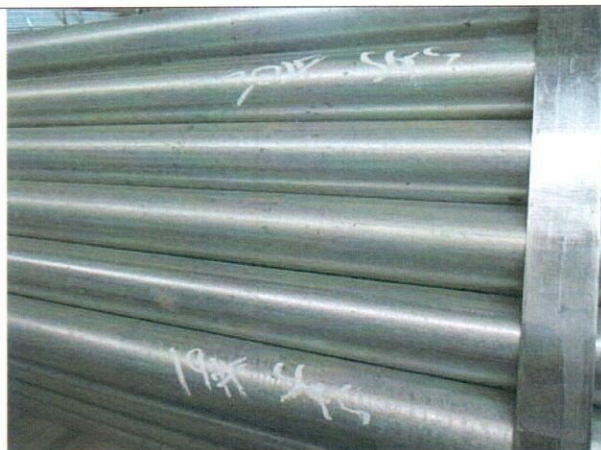
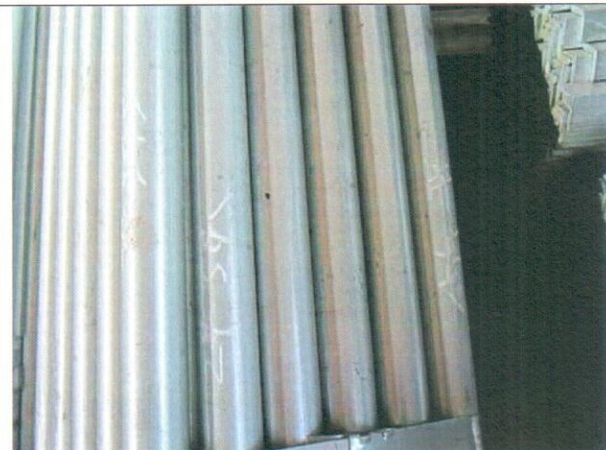
No marking was found on pipe body during the inspection.

Marking on inspected pipes

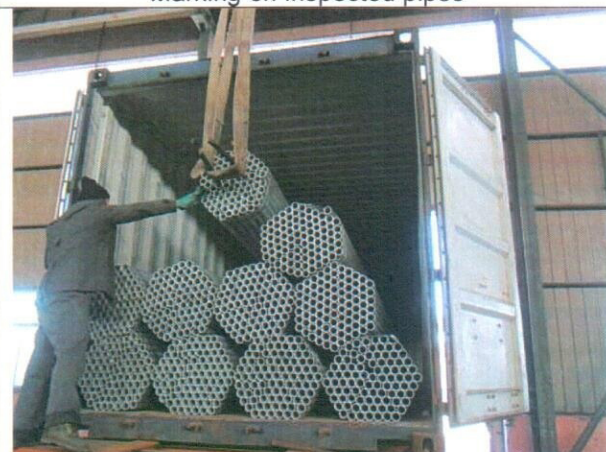
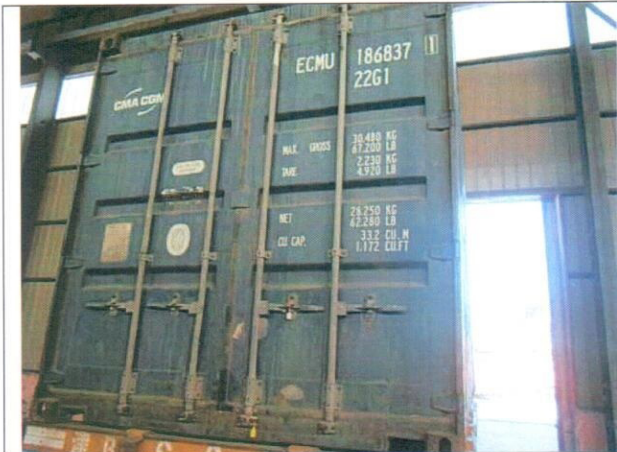
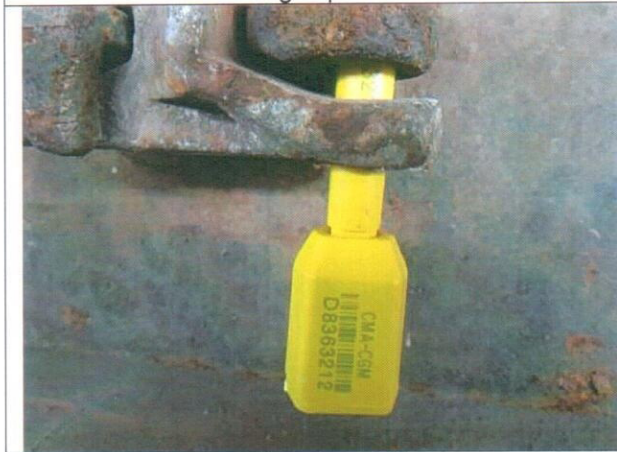
The above commodities were stuffed into 2x20FT containers under SGS supervision as following details:

Loading supervision

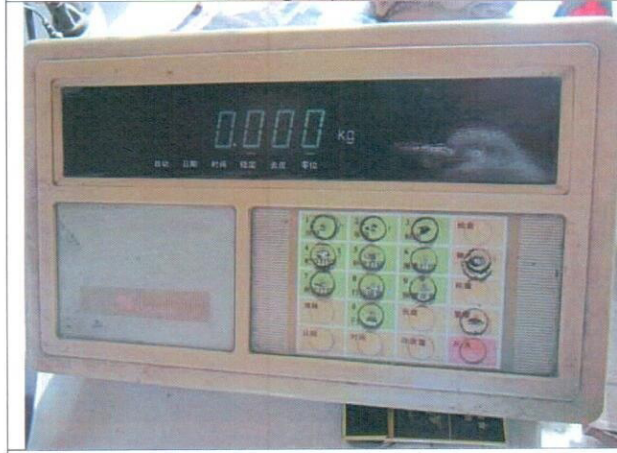
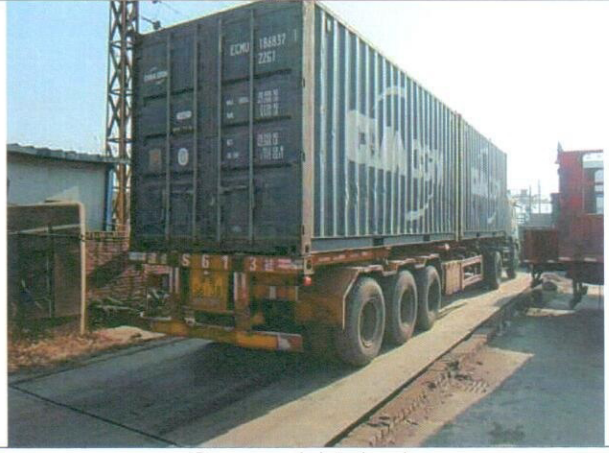
Truck No.	Empty weight (kg)	Filled with goods (kg)	Gross weight (kg)
1	17060	59930	42870
Total			42870

1. **The supplier/manufacturer did not submit the calibration certificate of weighbridge. so the above weight value was just for reference and SGS inspector can not verify the actual weight value.**

Gross weight check
